Manhole Inspection Summary

Manhole # S31EE_132MH

Insp Date: **10/7/08 2:56 PM**

Location Address: **236 DOLPHIN LN**

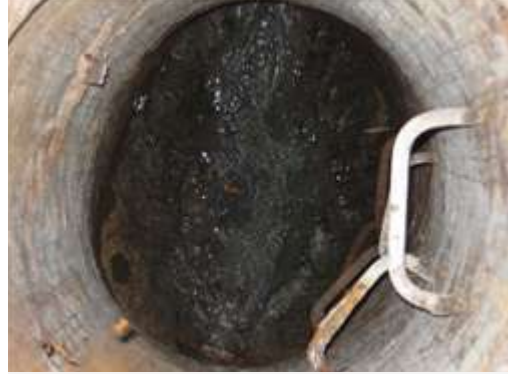
Top View

Corroded steps. Evidence of surcharge - Channel debris.

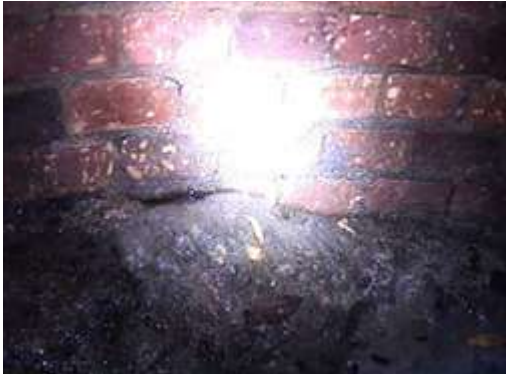
Defect

Infiltration: ☐ None ☐ Joint ☐ Cracks ☐ Mortar ☐ Roots ☒ **Wall**

Barrel infiltration.

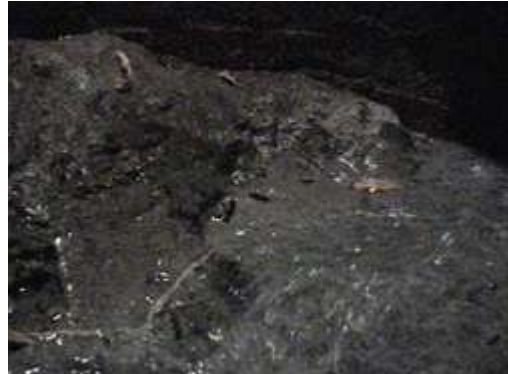
Defect

Condition: ☐ Sound ☐ Cracked ☐ Root Intrusion ☐ Loose Brick ☒ **Deteriorated**

Barrel deterioration and infiltration.

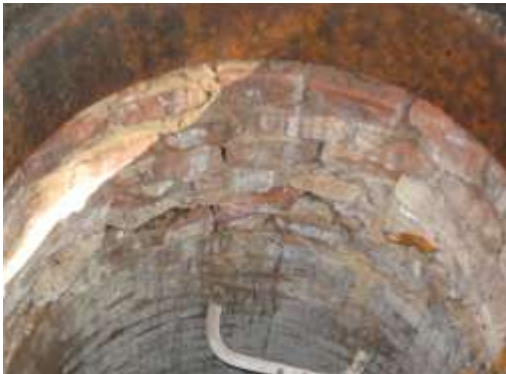
Defect

Condition: ☐ Sound ☐ Cracked ☐ Root Intrusion ☐ Loose Brick ☒ **Deteriorated**

Infiltration: ☐ None ☒ **Joint** ☐ Cracks ☒ **Mortar** ☐ Roots ☐ Wall

Infiltration: ☐ None ☐ Joint ☐ Cracks ☒ **Mortar** ☐ Roots ☒ **Wall**

Adjustment and Corbel deterioration and infiltration.

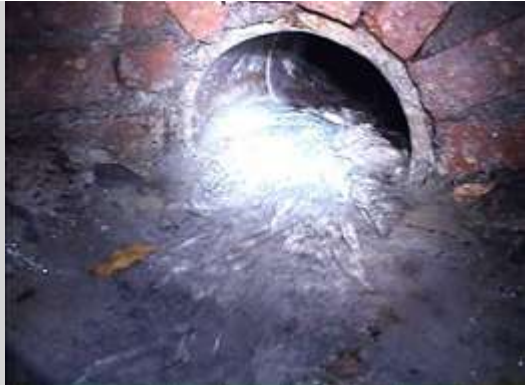
8 in. Circular Gravity Sewer Pipe Out @ 12 O'Clock

Infiltration: **Evidence** Pipe Seal Cond: **Broken**

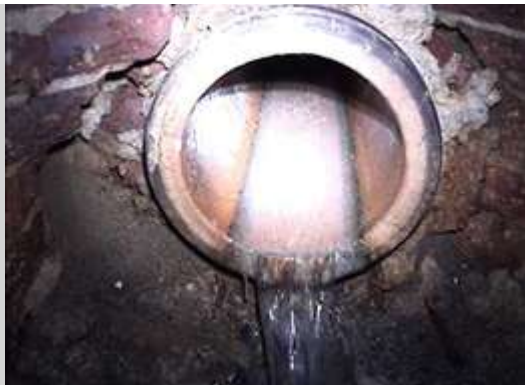
8 in. Circular Gravity Sewer Pipe In @ 6 O'Clock

Infiltration: **Evidence** Pipe Seal Cond: **Broken**
